LANTHEUS MEDICAL IMAGING: HIGH DOSIMETRY RESULT

MICHAEL REICHARD

EVENT REPORT

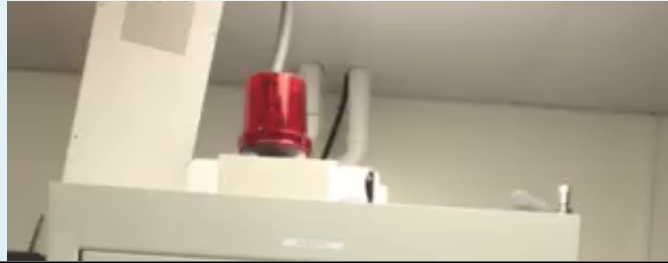
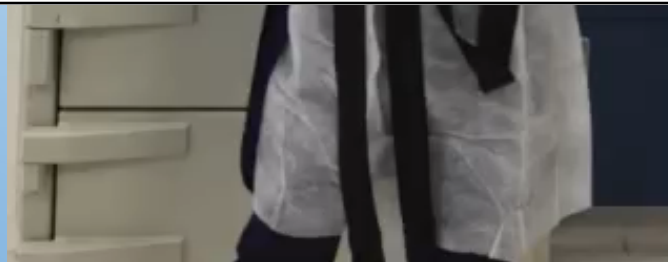
F-18 SYNTHESIZER

- The individual in question did not work with or perform maintenance on the cyclotron during the month of August.
- According to the use logs, the individual worked one “Hot Job” with a synthesizer. This activity included potential whole body exposures and contamination opportunities.
- Otherwise, the individual performed QA/QC functions with minimal opportunities for a whole body exposure of this magnitude.
- Licensee’s investigation looked at QA/QC functions, but focused on the “Hot Job.”

- We were initially skeptical of the rejection of a whole body dose.
- However, the activity remaining in the synthesizer was inadequate to produce the reported exposure. We pushed all of the assumptions in the conservative direction and we couldn't get an exposure that high.
- The synthesizer is engineered to be as efficient as possible. i.e. waste as little F-18 as possible.
- Perhaps that's an obvious statement, but we were glad we pushed the assumptions.
